## Memorandum

**To:** Daniel Harrison  
**From:** Victor Valenzuela, P.E.  
**Date:** February 17, 2016  
**Project Name:** Poor Creek Force Main Replacement Project  
**Project Number:** R14253R-02  
**Subject:** Poor Creek Force Main Condition Assessment Summary  
**cc:** Andy Snyder, Jason Garofalo (DAA)  
Kim Taylor, Ed Stelter (Faulconer)  
Joseph Modica (MBP)

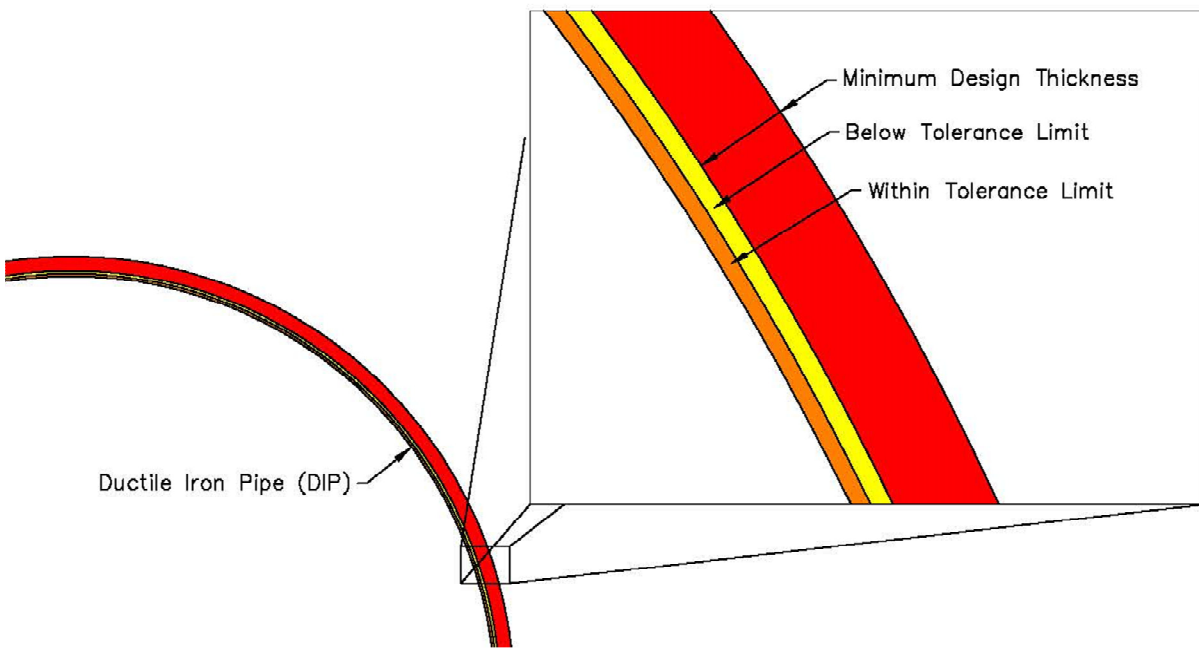
Table 2 - Summary: Ultrasonic Pipeline Wall Thickness Test Results							
Location	Assumed Pipe Class per Results	Measured Minimum Thickness	95% of Minimum Thickness	Thickness Tolerance Range		Min. Design Thickness	Existing Pipe Status
				in.	in.		
Test Pit #1A	50	0.306	<b>0.291</b>	0.36	0.29	0.21	Within Tolerance Limit
Test Pit #1	51	0.238	<b>0.226</b>	0.41	0.34	0.26	Below Design Minimum
Test Pit #2	---	---	---	---	---	---	---
Test Pit #3	56	0.518	<b>0.492</b>	0.56	0.49	0.41	Within Tolerance Limit
Test Pit #4	55	0.407	<b>0.387</b>	0.53	0.46	0.38	Below Tolerance Limit
Test Pit #5	55	0.477	<b>0.453</b>	0.53	0.46	0.38	Below Tolerance Limit
Test Pit #6	53	0.379	<b>0.36</b>	0.47	0.4	0.32	Below Tolerance Limit
Test Pit #6A	56	0.456	<b>0.433</b>	0.56	0.49	0.41	Below Tolerance Limit
Test Pit #6B	55	0.394	<b>0.374</b>	0.53	0.46	0.38	Below Design Minimum
Test Pit #6C	51	0.265	<b>0.252</b>	0.41	0.34	0.26	Below Design Minimum

Test Pit #6D	50	0.192	<b>0.182</b>	0.38	0.31	0.23	Below Design Minimum
Test Pit #7	55	0.485	<b>0.461</b>	0.53	0.46	0.38	Within Tolerance Limit
Test Pit #8	53	0.441	<b>0.419</b>	0.47	0.4	0.32	Within Tolerance Limit
Test Pit #9	53	0.439	<b>0.417</b>	0.47	0.4	0.32	Within Tolerance Limit
Test Pit #10	52	0.341	<b>0.324</b>	0.44	0.37	0.29	Below Tolerance Limit

The following figure provides a graphical representation of the observed pipe wall thicknesses and the existing pipe status designation:

Based on these results, it is DAA's recommendation that the city focus on the replacement or rehabilitation of pipe that has deteriorated to below the minimum design standards (the "red" areas shown on the previous table). This will help to prevent failures and overflows in these high risk areas. We recommend this replacement or rehabilitation include approximately 500 feet of force main adjacent to the National Park Service (NPS) property and approximately 4,000 feet of force main from adjunct to the Civil War Trust Property and the Virginia Holding Property.
